**Inn Condominium Owners Association
Garden City, UT**

Report #: 17079-5
Beginning: January 1, 2023
Expires: December 31, 2023

**RESERVE STUDY
Update "With-Site-Visit"**

May 20, 2022

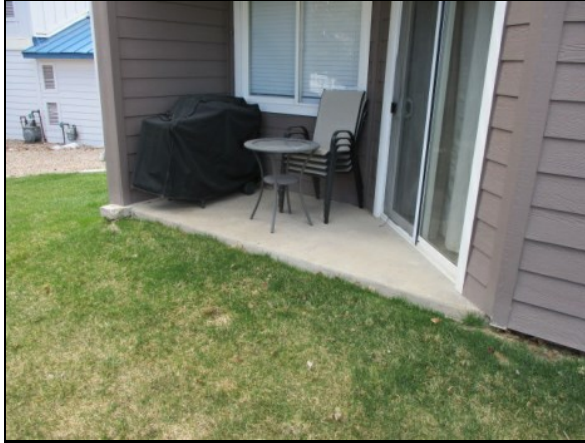
Comments: Patios are reported to be the maintenance and repair responsibility of the Client. Although complete replacement of all areas together should not be required conditions observed merit inclusion of an allowance for ongoing repairs and partial replacements. Timeline and cost ranges shown here should be re-evaluated during future Reserve Study updates.

Useful Life:
5 yearsRemaining Life:
0 years

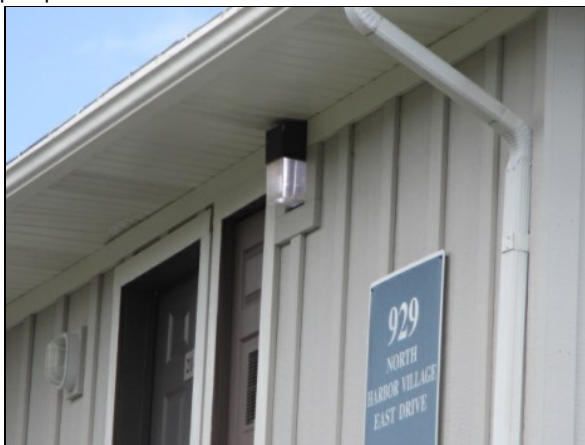
Comments: Exterior lights determined to be in fair condition typically exhibit more moderate signs of wear and age but are generally believed to be aging normally with no unusual conditions noted. Observed during daylight hours but assumed to be in functional operating condition. As routine maintenance clean by wiping down with an appropriate cleaner change bulbs and repair as needed. Best practice is to plan for replacement of all lighting together at roughly the time frame below for cost efficiency and consistent quality/appearance throughout development. Should be coordinated with exterior painting projects whenever possible. Individual replacements should be considered an Operating expense. If available an extra supply of replacement fixtures should be kept on-site to allow for prompt replacement.

Useful Life:
25 yearsRemaining Life:
20 years

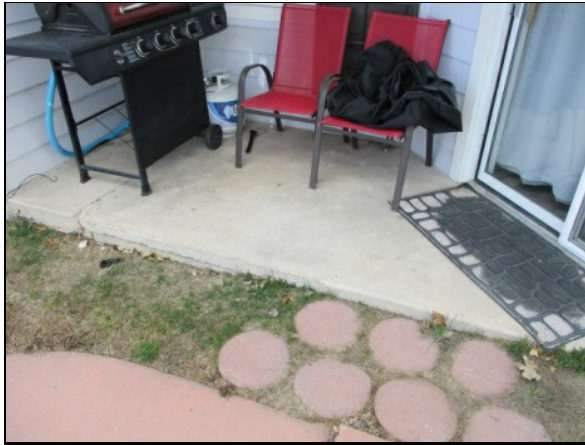
Comments: Patios are reported to be the maintenance and repair responsibility of the Client. Although complete replacement of all areas together should not be required conditions observed merit inclusion of an allowance for ongoing repairs and partial replacements. Timeline and cost ranges shown here should be re-evaluated during future Reserve Study updates.

Useful Life:
5 yearsRemaining Life:
0 years

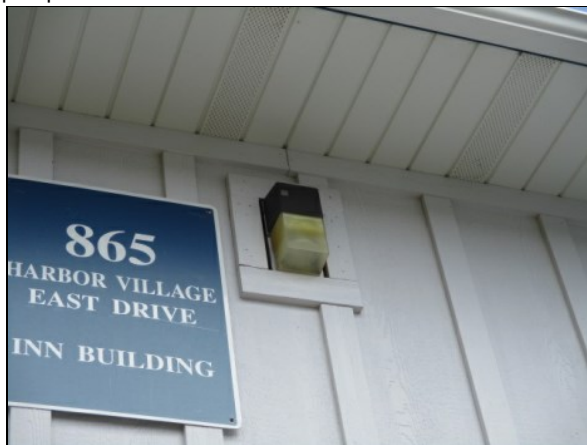
Comments: Exterior lights determined to be in fair condition typically exhibit more moderate signs of wear and age but are generally believed to be aging normally with no unusual conditions noted. Observed during daylight hours but assumed to be in functional operating condition. As routine maintenance clean by wiping down with an appropriate cleaner change bulbs and repair as needed. Best practice is to plan for replacement of all lighting together at roughly the time frame below for cost efficiency and consistent quality/appearance throughout development. Should be coordinated with exterior painting projects whenever possible. Individual replacements should be considered an Operating expense. If available an extra supply of replacement fixtures should be kept on-site to allow for prompt replacement.

Useful Life:
25 yearsRemaining Life:
19 years
