**Inn Condominium Owners Association
Garden City, UT**

Report #: 17079-5
Beginning: January 1, 2023
Expires: December 31, 2023

**RESERVE STUDY
Update "With-Site-Visit"**

May 20, 2022

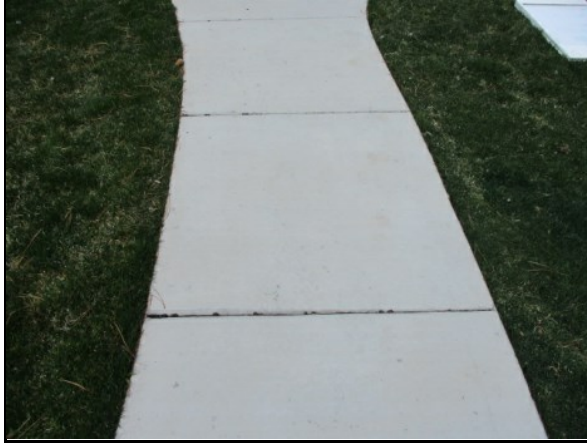
Comp #: 21090 Concrete Walkways - Repair - 5%

Useful Life:
5 years

Remaining Life:
1 years

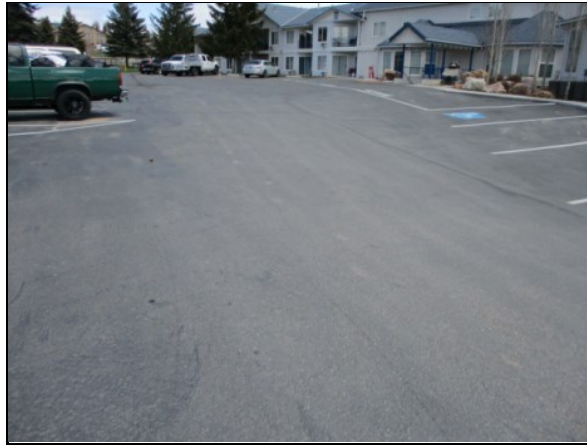
Useful Life:
4 years

Remaining Life:
0 years

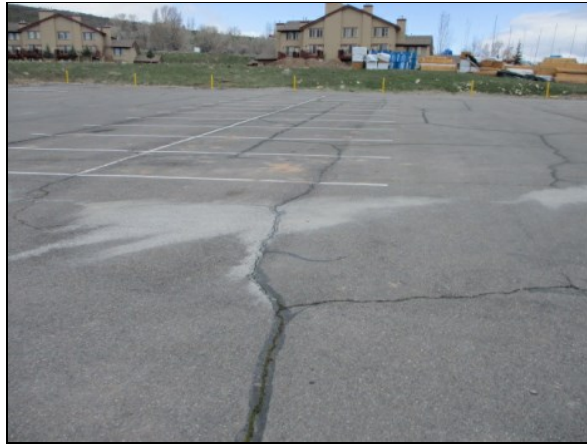
Useful Life:
4 years

Remaining Life:
0 years

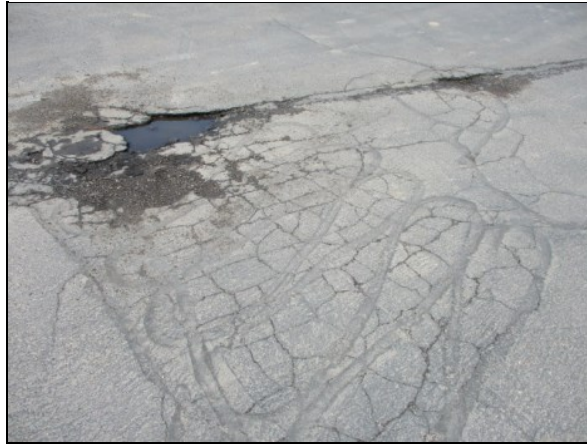
Useful Life:
25 years

Remaining Life:
4 years

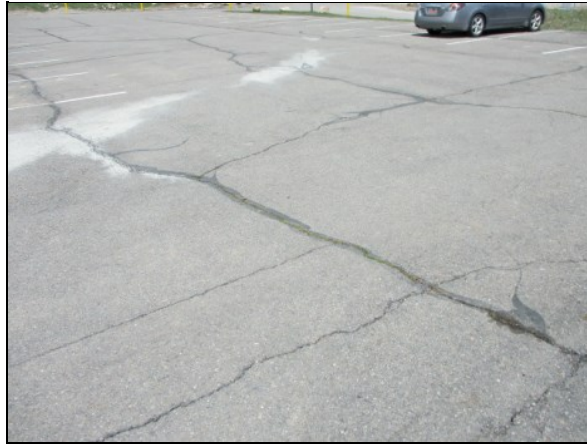
Useful Life:
25 years

Remaining Life:
4 years

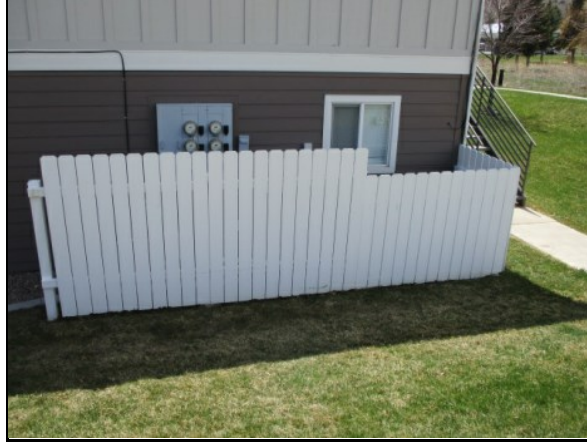
Comp #: 21350 Site Fencing: Vinyl - Replace

Useful Life:
30 years

Remaining Life:
12 years

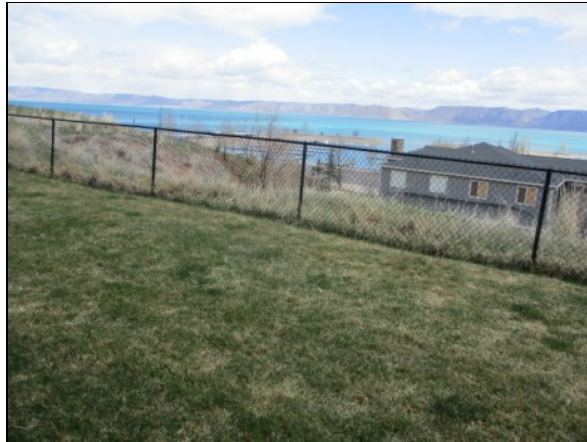
Useful Life:
30 years

Remaining Life:
15 years

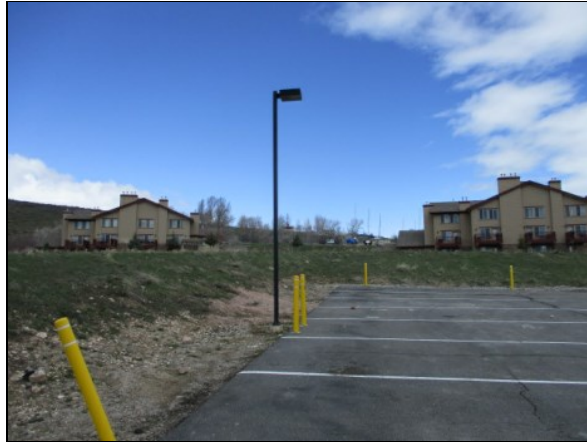
Useful Life:
30 years

Remaining Life:
1 years

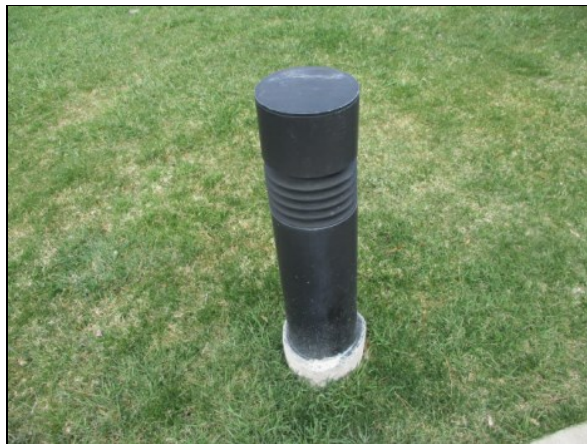
Useful Life:
30 years

Remaining Life:
3 years

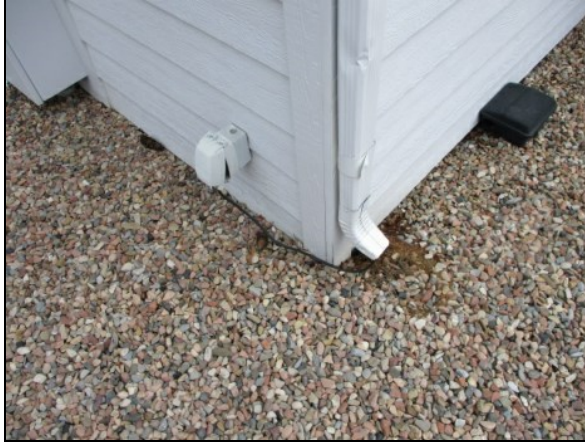
Comp #: 23660 Inn Heat Tape - Replace

Comments: The heat tape was reported to be in fair condition. No stripped or ripped taped noted or reported. Heat tape was observed along the edges of the roof and the downspouts. Heat tape generally follows the length of the gutter and downspouts. Heat cables when installed and functioning properly will help offset the likelihood of an ice dam. Heat tape on average creates an output between 50-70°F. When installed in the gutters the heat cables can keep your gutters and downspouts from collecting and freezing with ice and snow melt.

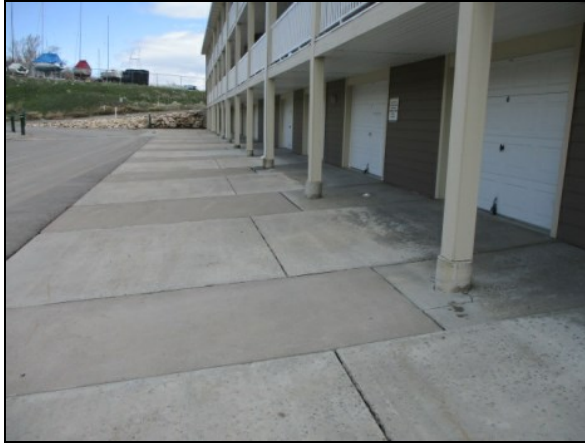
Comp #: 21050 Marina Drive Concrete - Repair - 5%

Comments: Driveways are reported to be the maintenance and repair responsibility of the Client. Although complete replacement of all areas together should not be required conditions observed merit inclusion of an allowance for ongoing repairs and partial replacements. Timeline and cost ranges shown here should be re-evaluated during future Reserve Study updates.

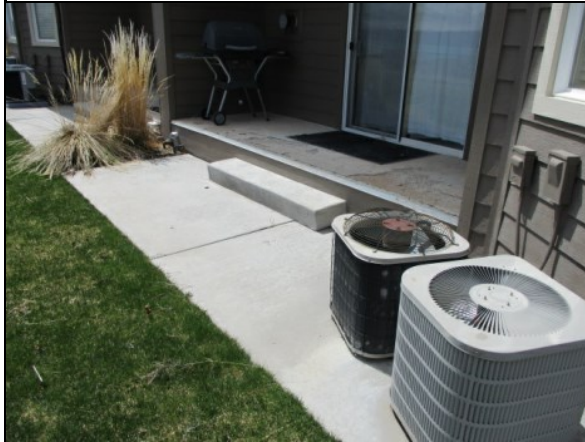
Comp #: 21090 Marina Patio Decks - Repair - 5%

Comments: Patios are reported to be the maintenance and repair responsibility of the Client. Although complete replacement of all areas together should not be required conditions observed merit inclusion of an allowance for ongoing repairs and partial replacements. Timeline and cost ranges shown here should be re-evaluated during future Reserve Study updates.

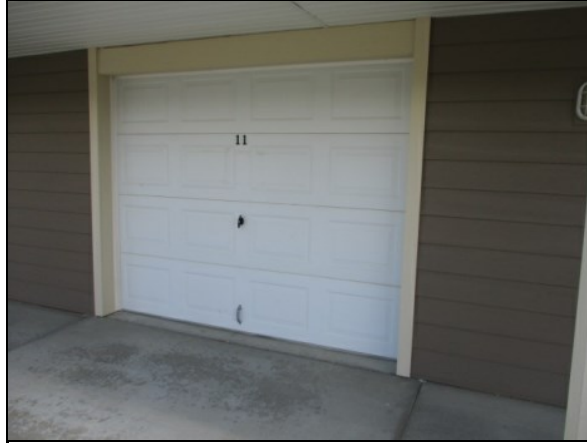
Comp #: 21490 Marina Garage Doors - Replace

Comments: Garage doors determined to be in fair condition typically exhibit more moderate signs of physical wear and tear. Appearance is still generally consistent but declining at this stage. Garage doors should have a long life expectancy under normal circumstances. Should be inspected and repaired as-needed as an Operating expense to ensure good function. Be sure to inspect internal components (springs tracks etc.) for damage and deterioration. For private garages individual owners are presumed to be responsible for replacement of the garage door opener. Doors should ideally be replaced in all areas at the same time to maintain consistent appearance and obtain better pricing through economies of scale. There are a wide variety of styles available and costs can vary greatly. Unless otherwise noted estimates shown here are based on replacement with type comparable to existing doors.

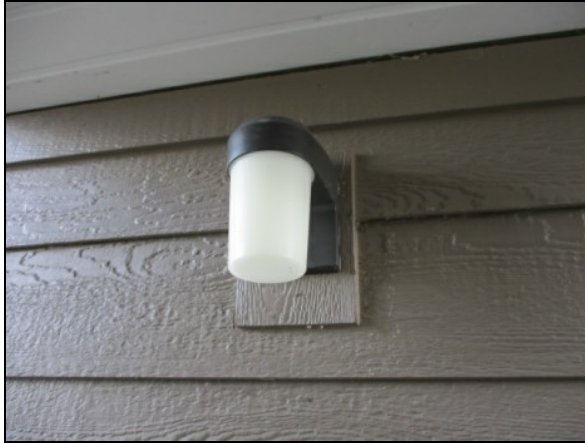
Comp #: 23020 Marina Ext. Lights - Replace

Comments: Exterior lights determined to be in fair condition typically exhibit more moderate signs of wear and age but are generally believed to be aging normally with no unusual conditions noted. Observed during daylight hours but assumed to be in functional operating condition. As routine maintenance clean by wiping down with an appropriate cleaner change bulbs and repair as needed. Best practice is to plan for replacement of all lighting together at roughly the time frame below for cost efficiency and consistent quality/appearance throughout development. Should be coordinated with exterior painting projects whenever possible. Individual replacements should be considered an Operating expense. If available an extra supply of replacement fixtures should be kept on-site to allow for prompt replacement.

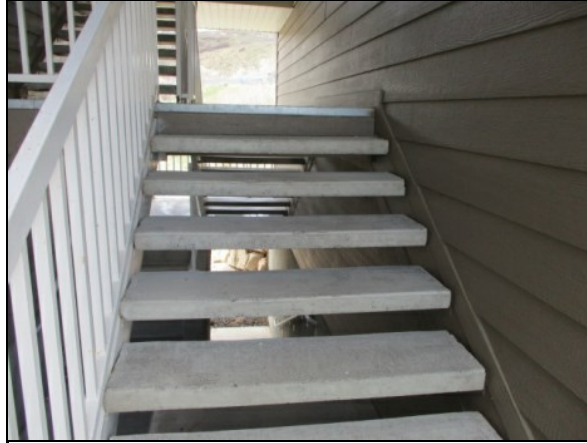
Comp #: 23110 Marina Concrete Treads - Replace

Comments: Steel staircases determined to be in fair condition typically exhibit routine signs of physical wear and tear, but no advanced deterioration is noteworthy. Appearance is typically declining at this stage, but staircases are physically aging normally. Staircases should be inspected regularly to ensure safety and stability; repair promptly as needed using general Operating funds. Make sure that all steps and landings drain properly to avoid standing water which can lead to slip and fall hazards. Inspect railings regularly for weakness or loose connections. In our experience, replacement needs may emerge as the community continues to age. Comprehensive replacement may be required at the approximate interval shown here based on our experience with similar client properties. In most cases, regular preventive maintenance can greatly extend the useful life of these types of staircases.

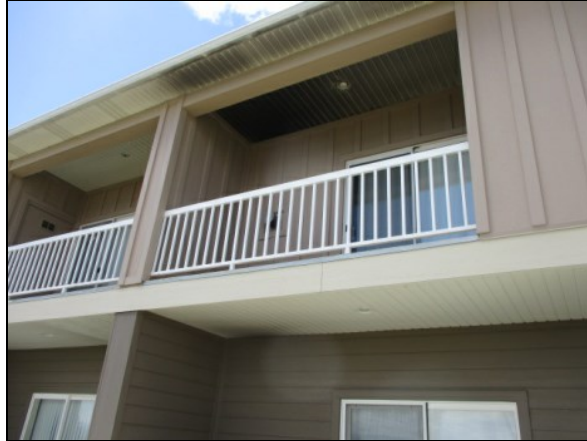
Comp #: 23180 Marina Duradeck Decks - Replace

Comments: Surface appearance was of that of a composite/plastic/PVC material. Typical warranty period based on a Trex type material is 25 years. However that warranty period is based on proper installation and maintenance. We recommend ongoing evaluations of all elevated decks by a qualified decking or waterproofing contractor to assess overall condition and performance of system components. As part of ongoing maintenance program inspect regularly for any damage/deterioration. Ensure that any rail assemblies are secure. Note project costs can vary significantly professional specifications soliciting several estimates and professional project oversight are recommended. Track actual expenses for inclusion within future Reserve Study updates. If properly installed composite decking systems should experience an extended useful life. Decks should be thoroughly evaluated by a decking or waterproofing contractor prior to re-coating in order to determine scope of any required repairs. If the deck system has a warranty the client should make sure to follow any requirements necessary to maintain said warranty such as re-coating at required intervals and conducting professional inspections. As a general rule potted plants and other items that may trap water should be elevated off the deck or used with a waterproof liner in order to prevent prolonged exposure.

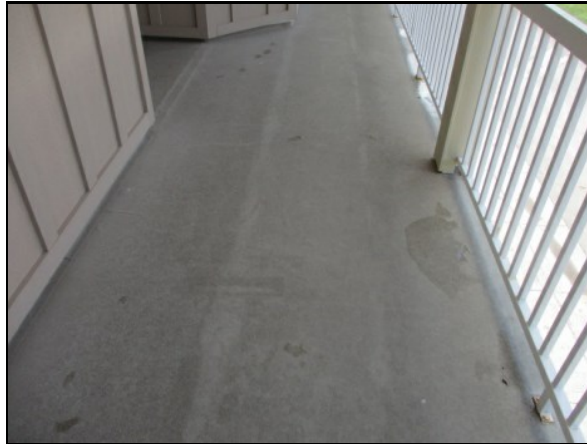
Comp #: 23180 Marina Walkway DuraDeck - Replace

Comments: Surface appearance was of that of a composite/plastic/PVC material. Typical warranty period based on a Trex type material is 25 years. However that warranty period is based on proper installation and maintenance. We recommend ongoing evaluations of all elevated decks by a qualified decking or waterproofing contractor to assess overall condition and performance of system components. As part of ongoing maintenance program inspect regularly for any damage/deterioration. Ensure that any rail assemblies are secure. Note project costs can vary significantly professional specifications soliciting several estimates and professional project oversight are recommended. Track actual expenses for inclusion within future Reserve Study updates. If properly installed composite decking systems should experience an extended useful life. Decks should be thoroughly evaluated by a decking or waterproofing contractor prior to re-coating in order to determine scope of any required repairs. If the deck system has a warranty the client should make sure to follow any requirements necessary to maintain said warranty such as re-coating at required intervals and conducting professional inspections. As a general rule potted plants and other items that may trap water should be elevated off the deck or used with a waterproof liner in order to prevent prolonged exposure.

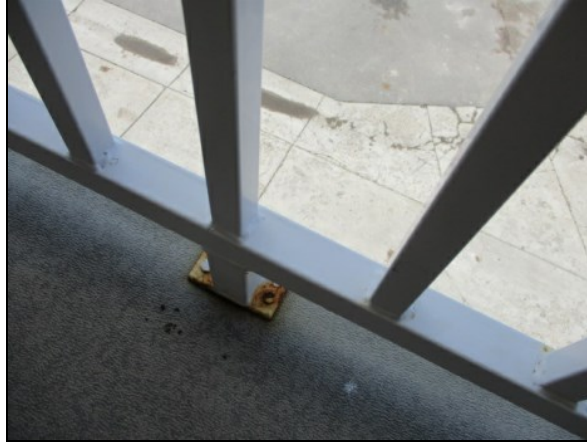
Comments: Deck railing finishes determined to be in poor condition typically exhibit minor to moderate wear with faded but consistent color. Coating is generally intact but may be beginning to peel or flake in sections. Railings should be painted/re-coated at the approximate interval shown below in order to restore good appearance and protect the railings from excessive surface wear. If railing is exposed to the elements without adequate coating for an extended period of time useful life may be severely reduced. Best practice is to coordinate with other exterior projects when possible such as deck re-coating or exterior painting.

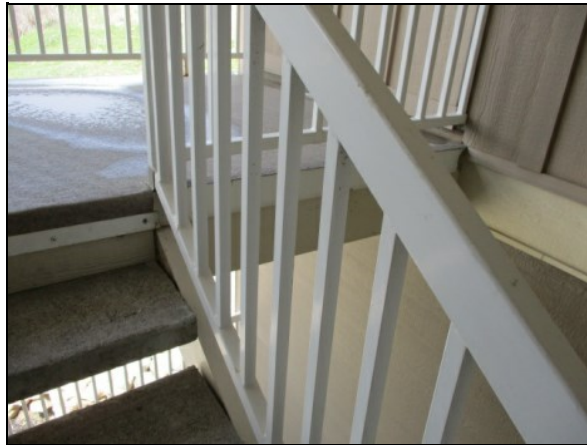
Comp #: 23230 Marina Deck & Stair Rails - Replace

Comments: Deck railings determined to be in fair condition typically exhibit some wear and age but are not showing any advanced structural concerns loose attachments rust etc. Appearance may be declining or outdated at this stage but railings are still performing their intended function. Post attachments and hardware should be inspected periodically for corrosion/rust and any waterproofing issues. As routine maintenance inspect regularly to ensure safety and stability repair promptly as needed using general operating/maintenance funds. We suggest Reserve funding for regular intervals of total replacement as indicated below. Unless otherwise noted costs shown are based on replacement with a similar style of railing. However if the client chooses to upgrade or replace with a different style costs may be substantially different. Any new information about changes in style should be incorporated into future Reserve Study updates.

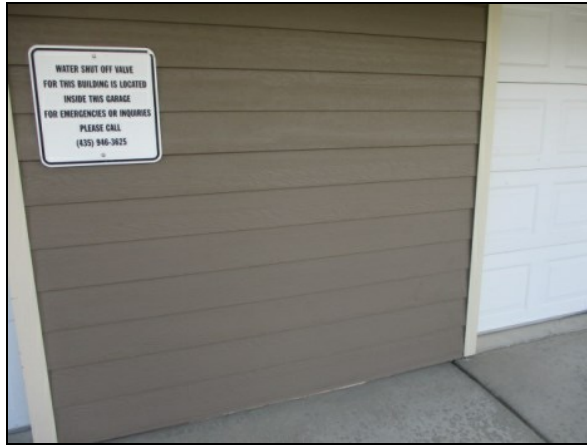
Comments: Fiber cement siding/trim sections determined to be in fair condition typically exhibit some color fading and inconsistency with minor isolated locations showing more advanced surface wear cracking splintering etc. Association Reserves does not specifically endorse any products manufacturers or vendors but James Hardie Building Products Inc. is the leading manufacturer of fiber cement siding and their website (www.jameshardie.com) is an informative resource for proper care and maintenance of fiber cement siding. Their Best Practices guidelines recommend the use of primers and topcoats that are designed and recommended for cement-based building materials such as fiber cement masonry brick or stucco. Two finish coats of high-quality exterior-grade acrylic paint are recommended. Their guidelines also recommend the use of elastomeric joint sealants complying with ASTM C920 Grade NS Class 25 or higher or latex joint sealants complying with ASTM C834. We recommend that the client consult with qualified exterior painting/waterproofing consultants and/or contractors to ensure that proper materials are used in painting and sealing the building siding. Plan for such projects at the interval shown here.

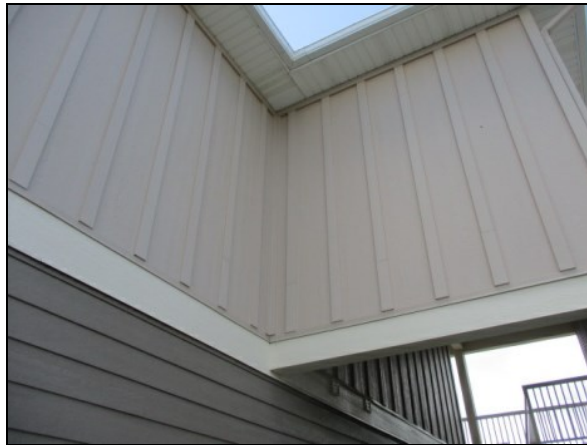
Comp #: 23390 Marina Fiber Cement Siding-Replace

Comments: The surfaces appeared in fair condition. No broken or missing sections observed. Minimal evidence of cracking fading and peeling observed. Siding was XX horizontal clapboard OR shingle OR board and batten XX. Surface was painted. Actual material of siding was not confirmed since we conducted only a limited visual review. Siding is believed to be fiber cement. The largest manufacturer of fiber cement siding is James Hardie Building Products Inc. and www.jameshardie.com is a good source of information for best practices related to installation care and maintenance of the product. At this time there is no well-defined limit to the useful life of fiber cement siding. The client should review any available warranty documents to ensure proper steps are taken to maintain applicable warranties. As the product ages the client should conduct more detailed inspections beyond the scope of the visual inspection conducted during this engagement. Currently Hardie offers the choice of a 30-year non-prorated or 50-year pro-rated warranty. James Hardie recommended maintenance tips include: • Patching - Dents chips and cracks can be filled using a good quality cement patching compound (acrylic mortar patch) which can be found at your local Home Center or Hardware Store. • Mold/Mildew - Remove using a commercial mold/mildew remover. Consult your paint manufacturer's recommendations before applying any mold or mildew remover. • Loose Siding or Soffit- Re-nail using a properly-sized corrosion-resistant fastener. • Caulk Replacement - When sealant is in need of replacing carefully remove existing caulk and replace with a high quality paintable latex caulk. For best results use a latex caulk that complies with ASTM-C- 834 ASTM C920 or better. Caulking should be applied in accordance with the caulking manufacturer's written installation instructions. • Paint Maintenance - Remove any damaged chipped or cracked paint. Prior to repainting make sure that the surface area is properly cleaned and prepared. Repaint immediately using 100% acrylic paint. • Note: For best results please refer to your paint manufacturer's written specifications for application rates and required topcoats or refer to James Hardie's Technical Bulletin No. S-100. The underlying waterproofing will degrade over time and may require replacement. No view of underlying waterproofing was part of our limited visual review. The client should plan for eventual replacement at roughly the time-frame below. Inspect and repair as needed using operating and maintenance funds.

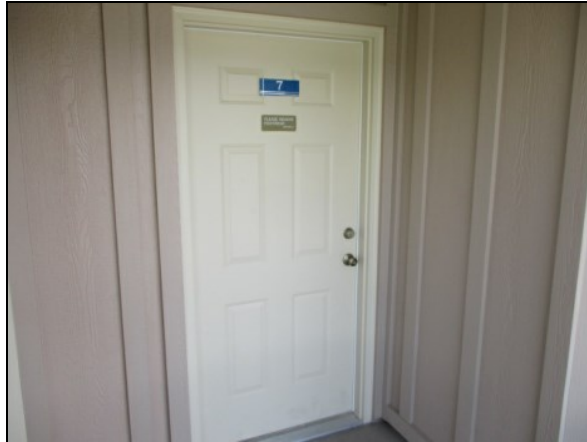
Comp #: 23470 Marina Unit/Utility Doors - Replace

Comments: Generally fair condition noted with no widespread damage or wear. No major cracking fading or weathering noted. Doors should have a very long useful life expectancy in most cases. However occasional replacements may be required especially for doors located in more exposed areas. Inspect periodically and repair as needed to maintain appearance security and operation with maintenance funds. Should be painted along with building exteriors or other painting/waterproofing projects to preserve appearance and prolong useful life. Based on our experience with comparable properties we recommend planning for ongoing partial replacements at the approximate interval shown here.

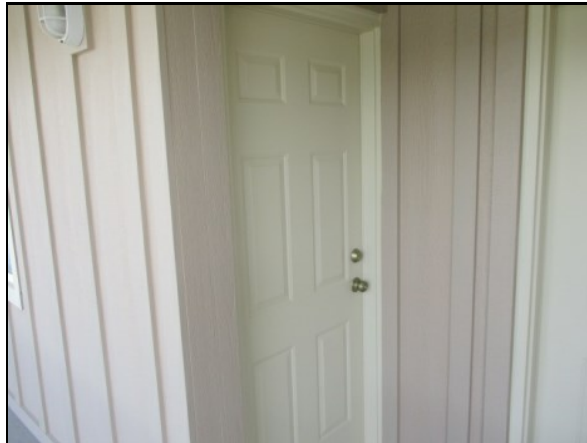
Comments: The painted surface of the doors appeared in fair condition with minimal peeling and blistering of the painted observed. Regular uniform professional paint or sealer applications are recommended for appearance protection of wood and maximum design life. Repair as needed and clean prior to application. Plan for regular applications as shown below.

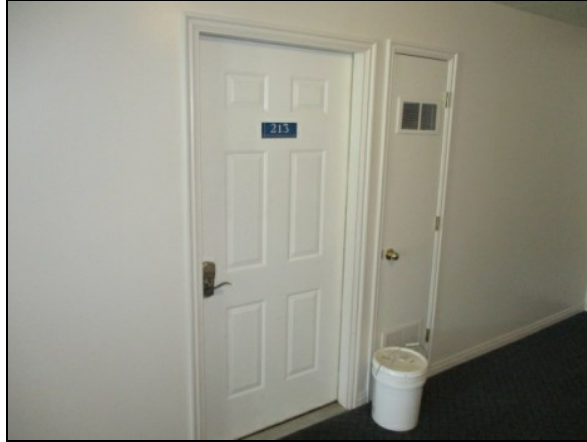
Comp #: 24130 Interior Doors - Replace

Generally fair condition noted with no widespread damage or wear. No major cracking fading or weathering noted. Doors located inside protected interior areas can have very long life expectancies. In our experience it is prudent to expect replacement at the approximate interval shown below in order to maintain good appearance consistent with other interior areas. Timing of replacements is ultimately subjective.

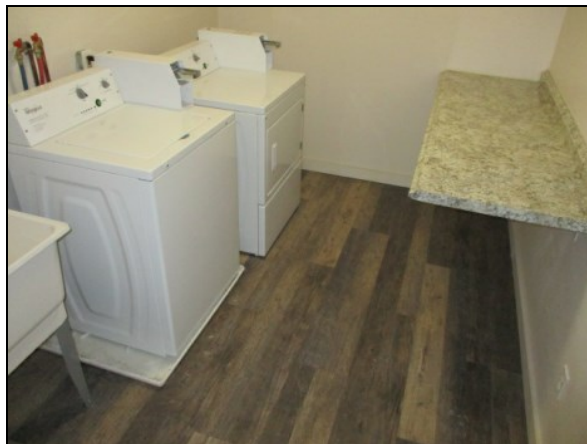
Comments: Room was observed to be in fair condition. Flooring was mostly clean and free of any major issues. Fixtures appeared to be in good condition. Laundry rooms should be remodeled at the approximate interval shown below based on our experience with other clients. Remodeling typically includes replacement of flooring and other finishes (wallcoverings etc.) as well as painting and can also include installation/replacement of lighting counter tops etc. Costs can vary depending on the type and quality of replacement materials. Should ideally be coordinated with remodeling of any other amenity areas to maintain consistency in the common areas.

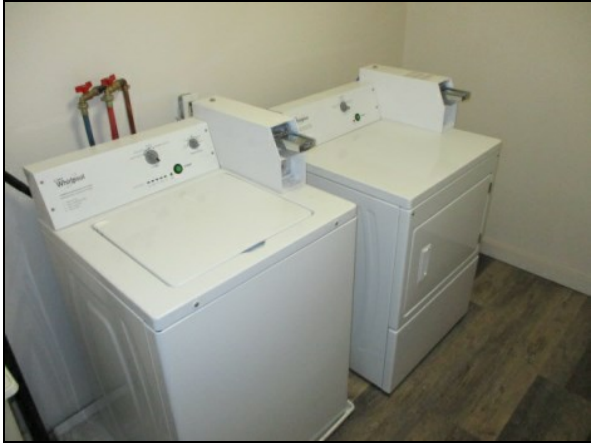
Comp #: 24400 Inn Laundry Machines - Replace

Comments: Includes (1) Washer (1) Dryer. Laundry rooms determined to be in poor condition typically exhibit advanced signs of wear and age such as damaged or deteriorated flooring peeling paint or wallpaper and/or inadequate lighting. Even if laundry rooms are still in fair condition however remodeling may be warranted when machines are replaced or to maintain consistency with other common areas.

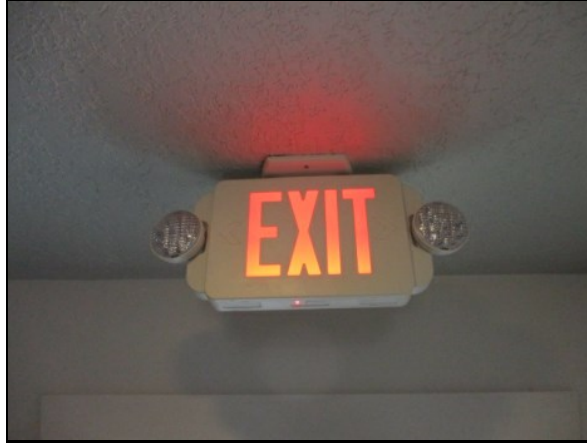
Comp #: 25420 Inn Exit Fixtures - Replace

Comments: Includes (6) Exit Signs. Minimal or no subjective/aesthetic value for this component. Useful life is based primarily on normal expectations for service/performance life in this location. Unless otherwise noted remaining useful life expectancy is based primarily on original installation or last replacement/purchase date our experience with similar systems/components and assuming normal amount of usage and good preventive maintenance. Exit signs were not tested for functionality during site inspection. Replacement of individual signs can be included within the general maintenance and repair category of the Operating budget. Large-scale replacement of many (or all) fixtures may be warranted at some point and should ideally be coordinated with other life-safety components (i.e. fire alarm components) or with other lighting. There is a wide variety of fixture styles available with a wide range of associated costs. Funding here to replace with fixtures comparable to those currently in place.

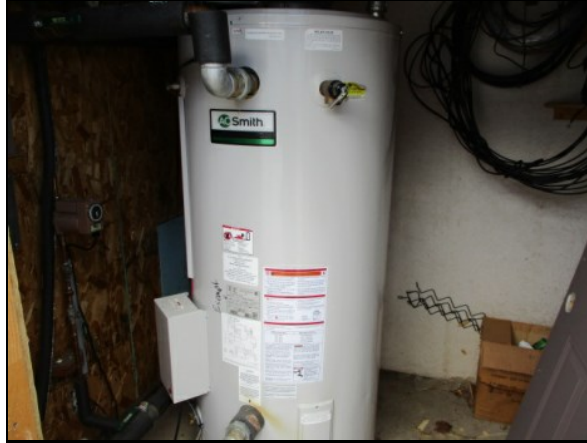
Comp #: 25460 14-Plex Water Heater - Replace

Comments: Includes (1) AO Smith 100 Gallon Tank. Model: BTR197119 S/N: 1248M000407. Replaced in 2013 for \$6218. Minimal or no subjective/aesthetic value for this component. Useful life is based primarily on normal expectations for service/performance life in this location. Unless otherwise noted remaining useful life expectancy is based primarily on original installation or last replacement/purchase date our experience with similar systems/components and assuming normal amount of usage and good preventive maintenance. Water heater life expectancies can vary greatly depending on level of use type of technology amount of preventive maintenance and other factors. Should be inspected and repaired as needed by servicing vendor or maintenance staff. Unless otherwise noted expected to be functional. Plan to replace at the approximate interval shown below. When evaluating replacements we recommend choosing high-efficiency or tankless models if possible in order to minimize energy usage.

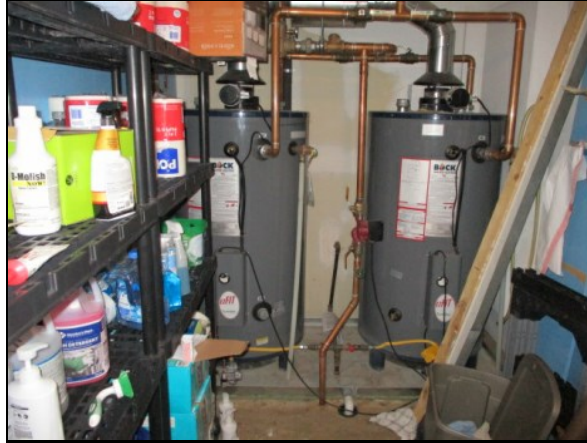
Comp #: 25460 Inn Bldg. Water Heaters - Replace

Comments: Includes (2) 100 Gallon Water Heaters - Model EZ100-199LP (1) S/N: 14113245T (1) S/N: 14113243T.. Minimal or no subjective/aesthetic value for this component. Useful life is based primarily on normal expectations for service/performance life in this location. Unless otherwise noted remaining useful life expectancy is based primarily on original installation or last replacement/purchase date our experience with similar systems/components and assuming normal amount of usage and good preventive maintenance. Water heater life expectancies can vary greatly depending on level of use type of technology amount of preventive maintenance and other factors. Should be inspected and repaired as needed by servicing vendor or maintenance staff. Unless otherwise noted expected to be functional. Plan to replace at the approximate interval shown below. When evaluating replacements we recommend choosing high-efficiency or tankless models if possible in order to minimize energy usage.

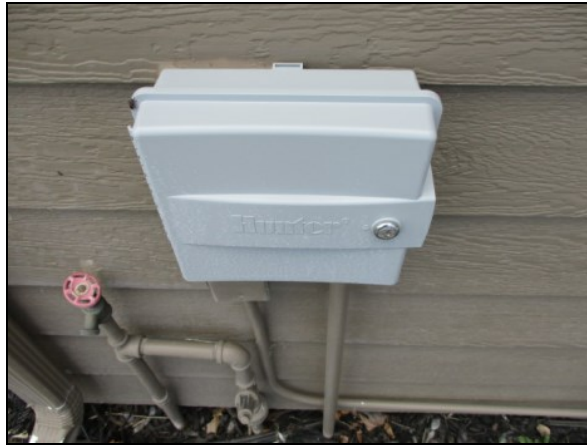
Comp #: 25570 Irrigation Clocks - Replace - 25%

Comments: Includes (3) Hunter Clocks - marina and 14plex and inn common area (1) Rain bird tennis. Minimal or no subjective/aesthetic value for this component. Useful life is based primarily on normal expectations for service/performance life in this location. Unless otherwise noted remaining useful life expectancy is based primarily on original installation or last replacement/purchase date our experience with similar systems/components and assuming normal amount of usage and good preventive maintenance. Irrigation controllers should have a relatively long life expectancy under normal circumstances. Replacement is often required due to lack of available replacement parts lightning strikes etc. as opposed to complete failure of existing equipment. Exposure to the elements can affect overall life expectancy and controllers should be located in protected areas or within protective enclosures whenever possible. When evaluating replacement options the client should consider replacement with smart" models (i.e. respond to projected weather data) to minimize unnecessary water usage. Payback period for efficient controllers that minimize water use is typically very short
